8 (1)
AD 73767
MISCELLANEOUS PAPER NO. 4-886

EVALUATION OF THREE-PIECE AM2 ALUMINUM LANDING MAT

Naval Air Engineering Center
Philadelphia, Pennsylvania

U. S. Army Engineer Waterways Experiment Station
CORPS OF ENGINEERS
Vicksburg, Mississippi

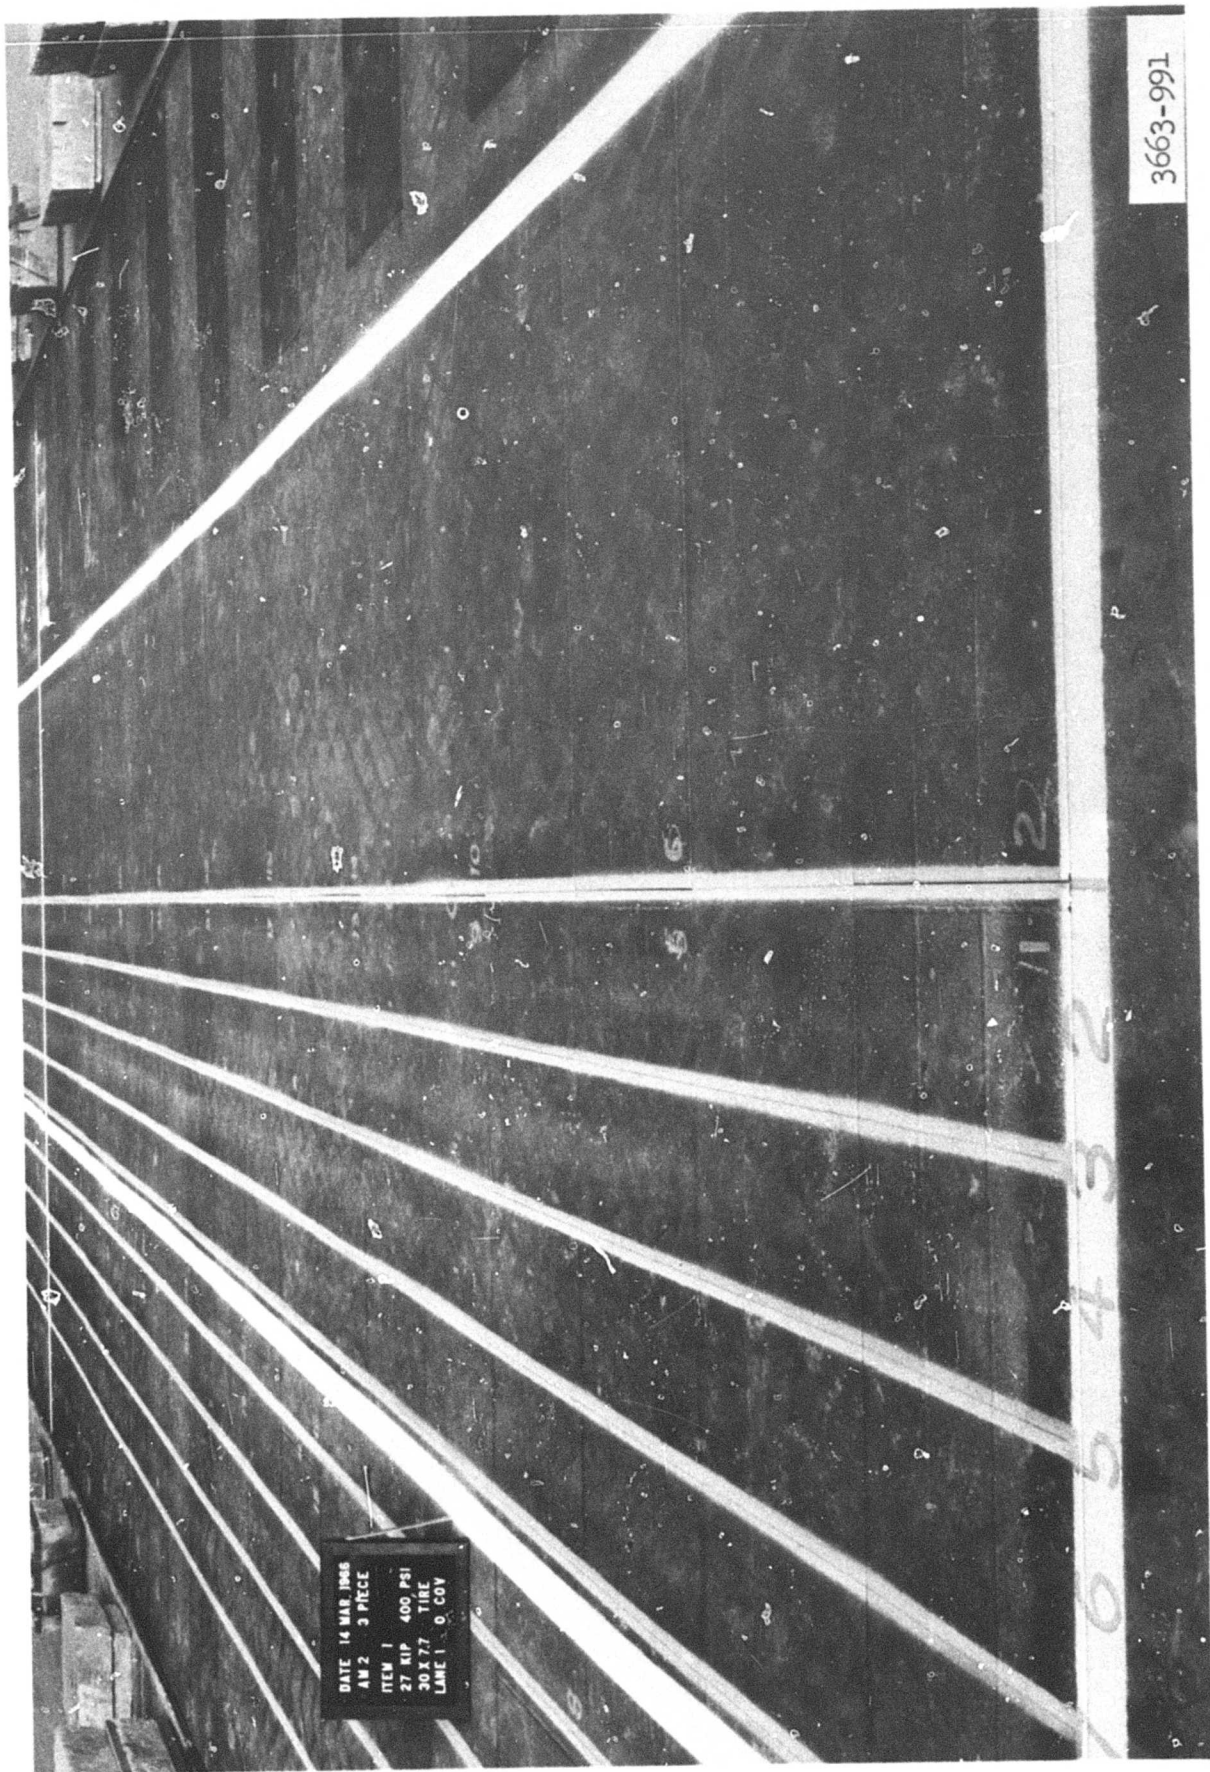
Photograph 1. Item 1, test lane 1, prior to traffic

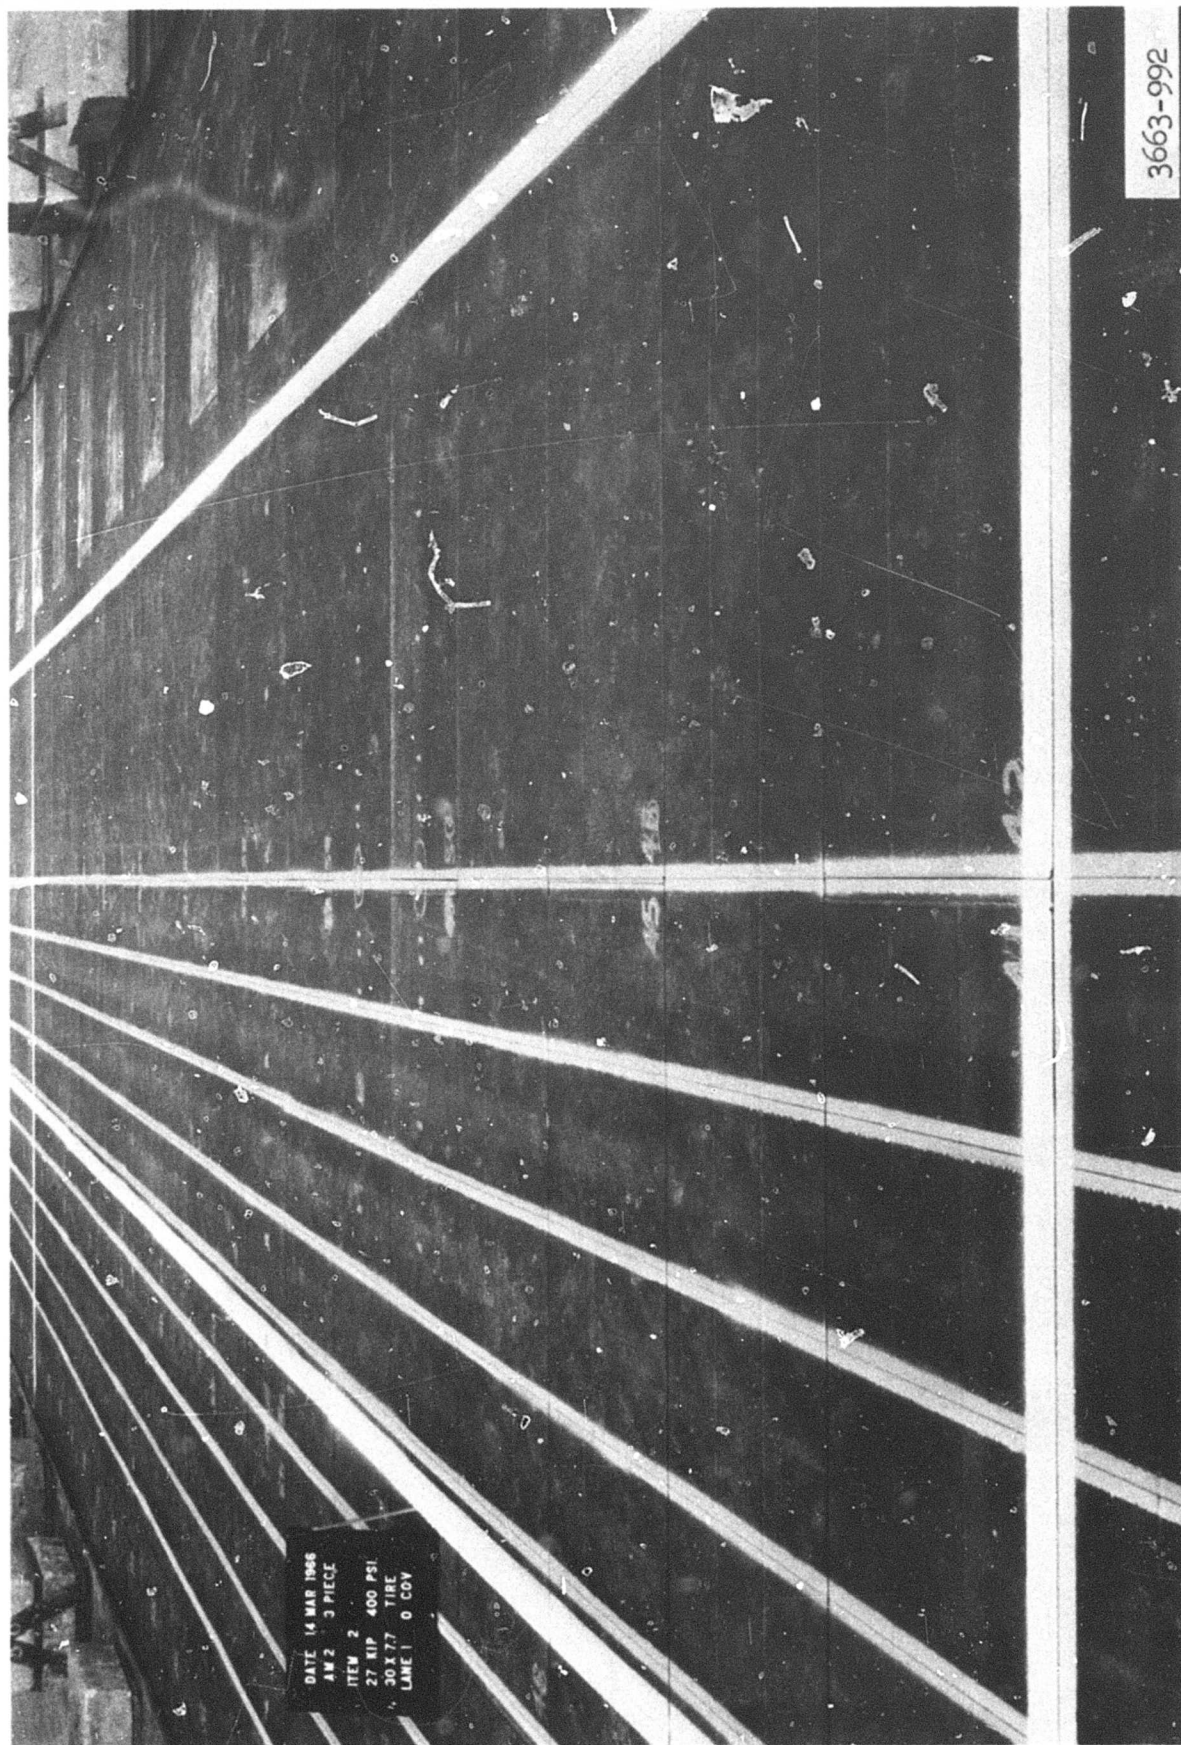
Photograph 9. General view of item 2, lane 1, prior to traffic

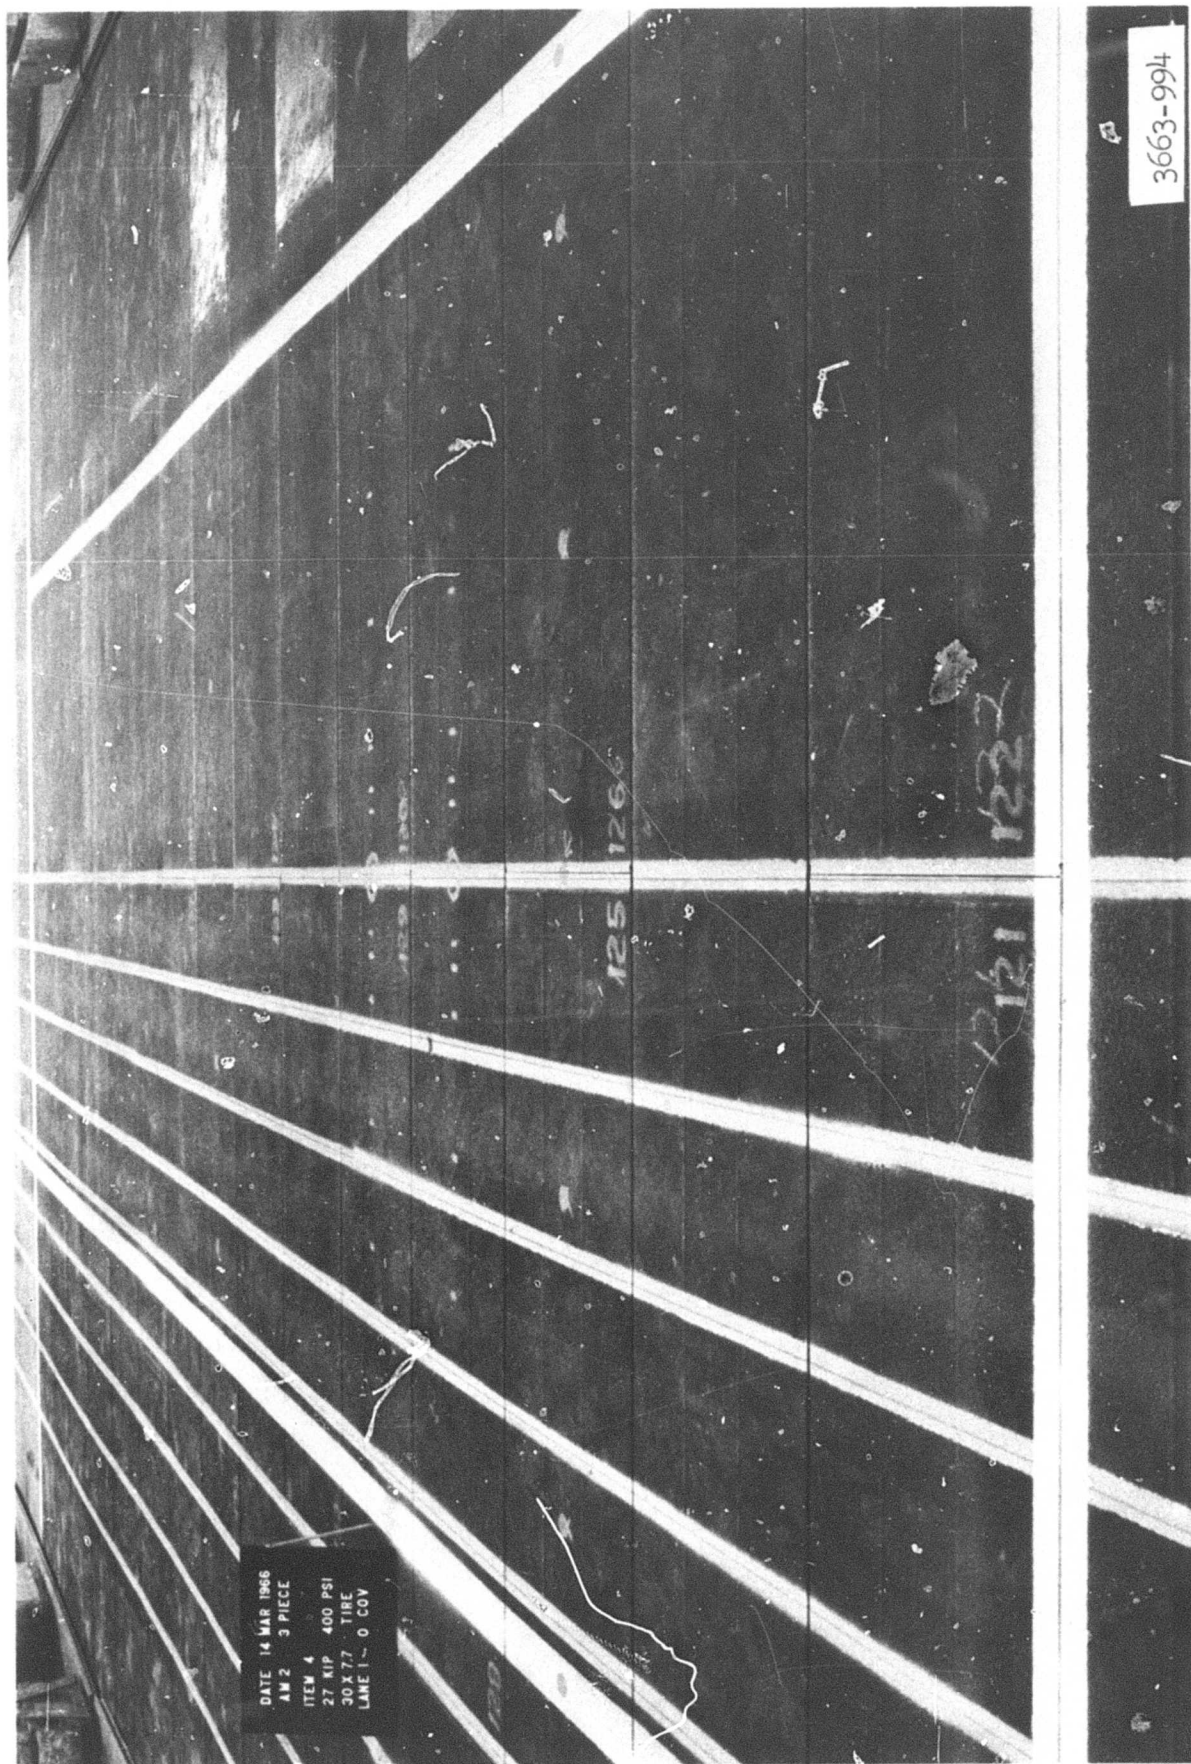
Photograph 15. General view of item 4, lane 1, prior to traffic

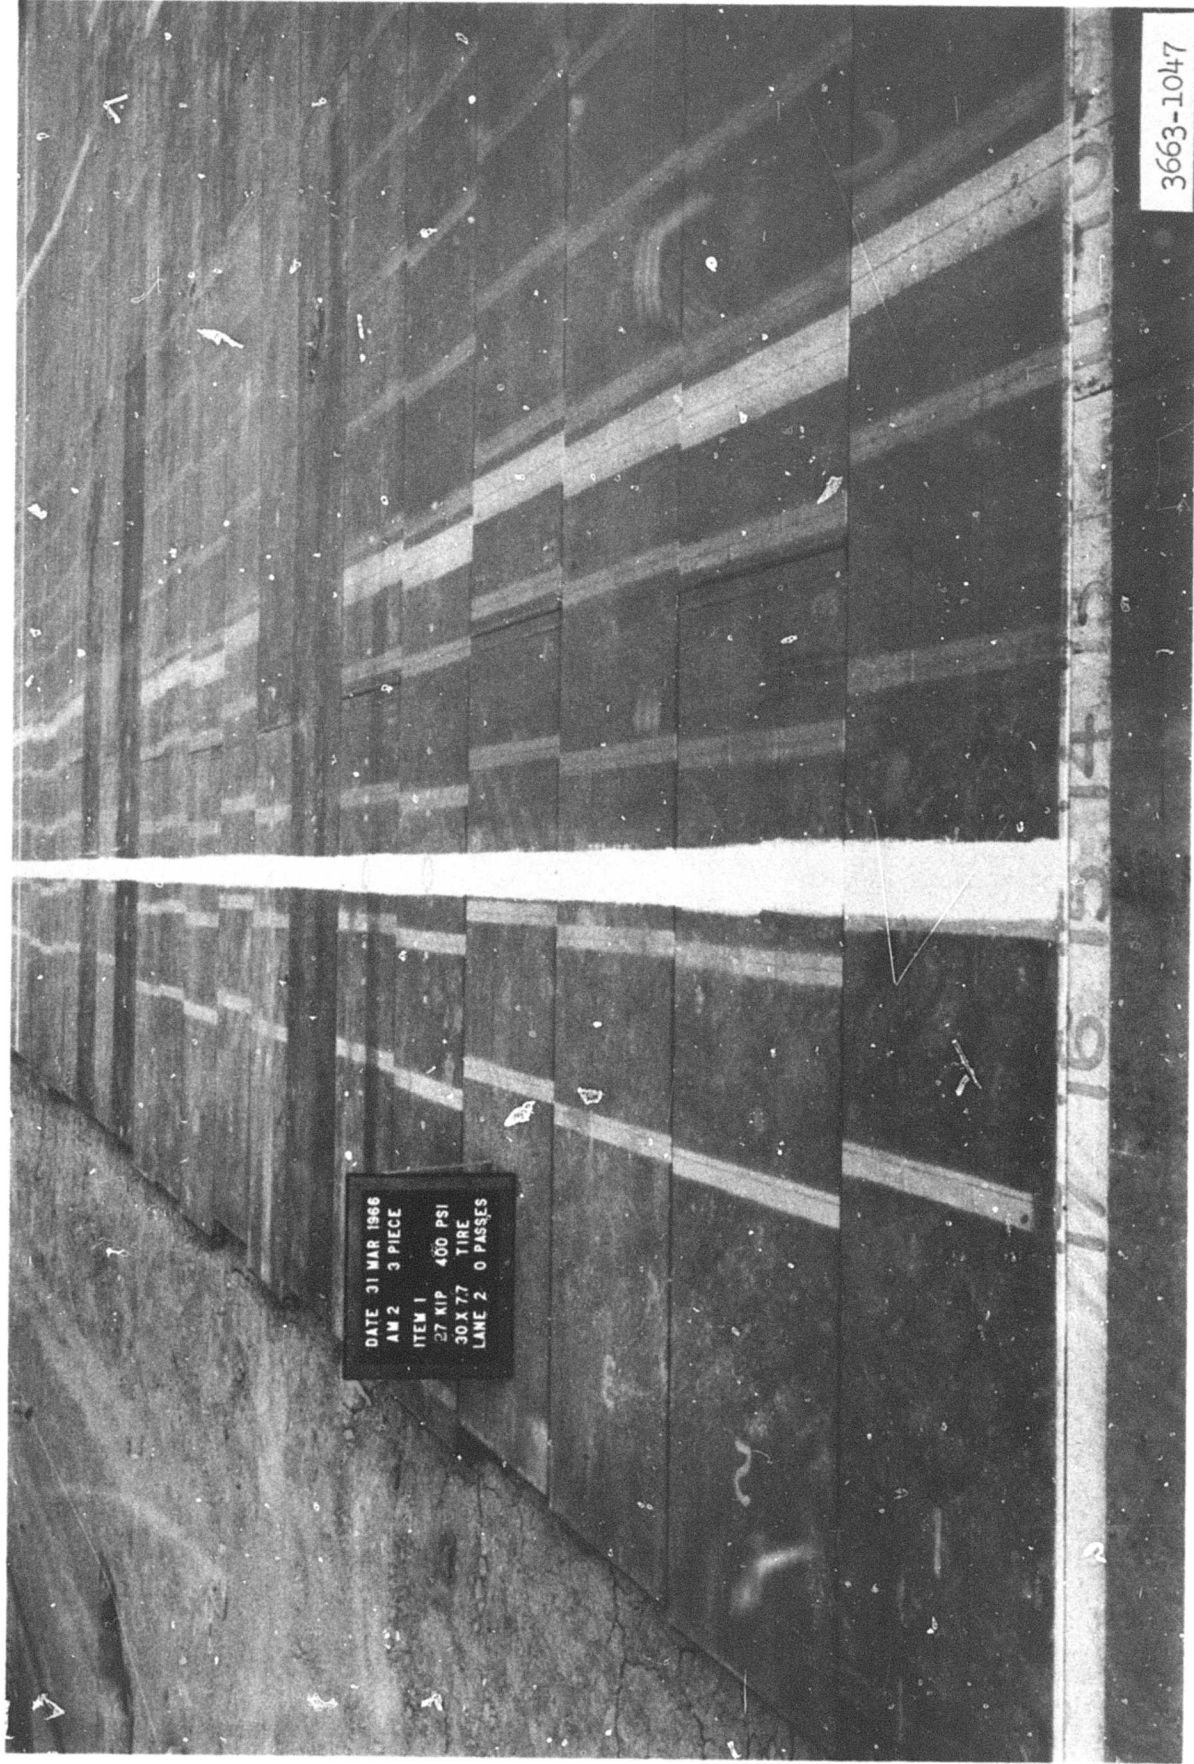
28. Item 1. When the weights were removed from the east edge of the mat, the mat ends sprang upward 2 to 3 in. as a result of deformation in test lane 1. Therefore, the mat was not in continuous contact with the subgrade. A general view of item 1 prior to traffic is shown in photograph 17. The effects of traffic were first noticed at 740 passes when a slight amount of dishing was observed in the individual extrusions of several planks (photograph 18). Dishing measurements were made in each of the three extrusions of each plank, but generally dishing was not noticeable until it progressed to about $3/16$ in. deep. At about $3/8$ in. dishing depth, an extrusion was considered to have a core failure which generally was indicated by an accompanying skin or weld break. The first mat break was noticed at 806 passes in plank 5. There was a $1/4$ -in.-deep dish in the extrusion on the south side of the plank, and the adjacent longitudinal weld had a $2-1/2$ -in. crack. At 1000 passes, a skin tear appeared in plank 5 adjacent to the longitudinal weld crack, as shown in photograph 19. In addition, on plank 3 a 5-in.-long crack had developed in the longitudinal weld on the south side of the plank, and there was a dish approximately $1/4$ in. deep in the south extrusion. At this time, three additional planks with areas of apparent core damage were noted. The item was in good condition, generally, although there had been some lateral

Photograph 17. Item 1, lane 2, prior to traffic

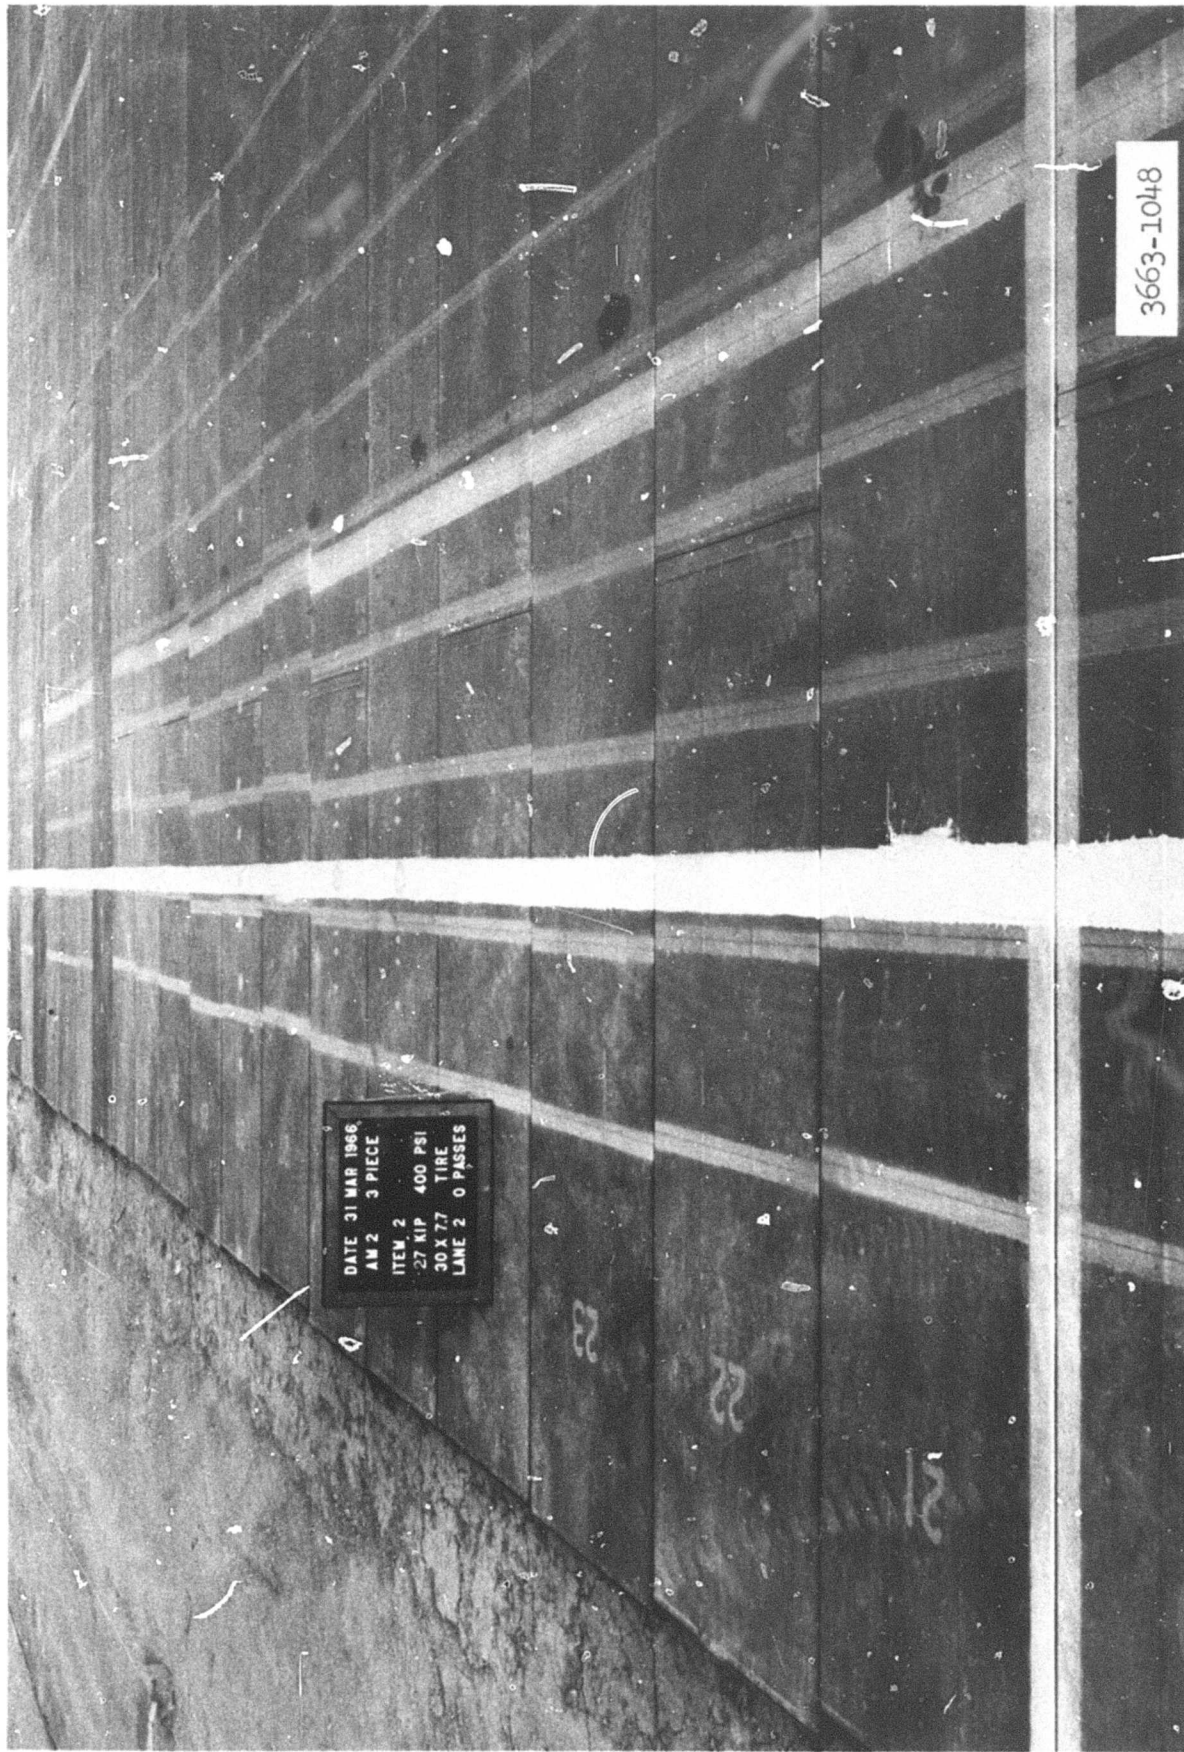
29. Item 2. A general view of item 2 prior to traffic is shown in photograph 22. This item withstood trafficking without significant visible effects until 1320 passes, at which time it was observed that eight planks had slightly dished extrusions. At 1520 passes, a large crack had occurred in the longitudinal weld on the south side of plank 61 and a skin tear at the same relative position on plank 77 (photograph 23). Both breaks appeared suddenly and as a result of core damage. After 1600 passes, traffic was stopped. At this time, in addition to planks 61 and 77, there were 14 areas of apparent core damage in the item. In about half of the damaged planks failure appeared to be imminent, and the item was generally in poor condition (photograph 24).

Photograph 22. Item 2, lane 2, prior to traffic

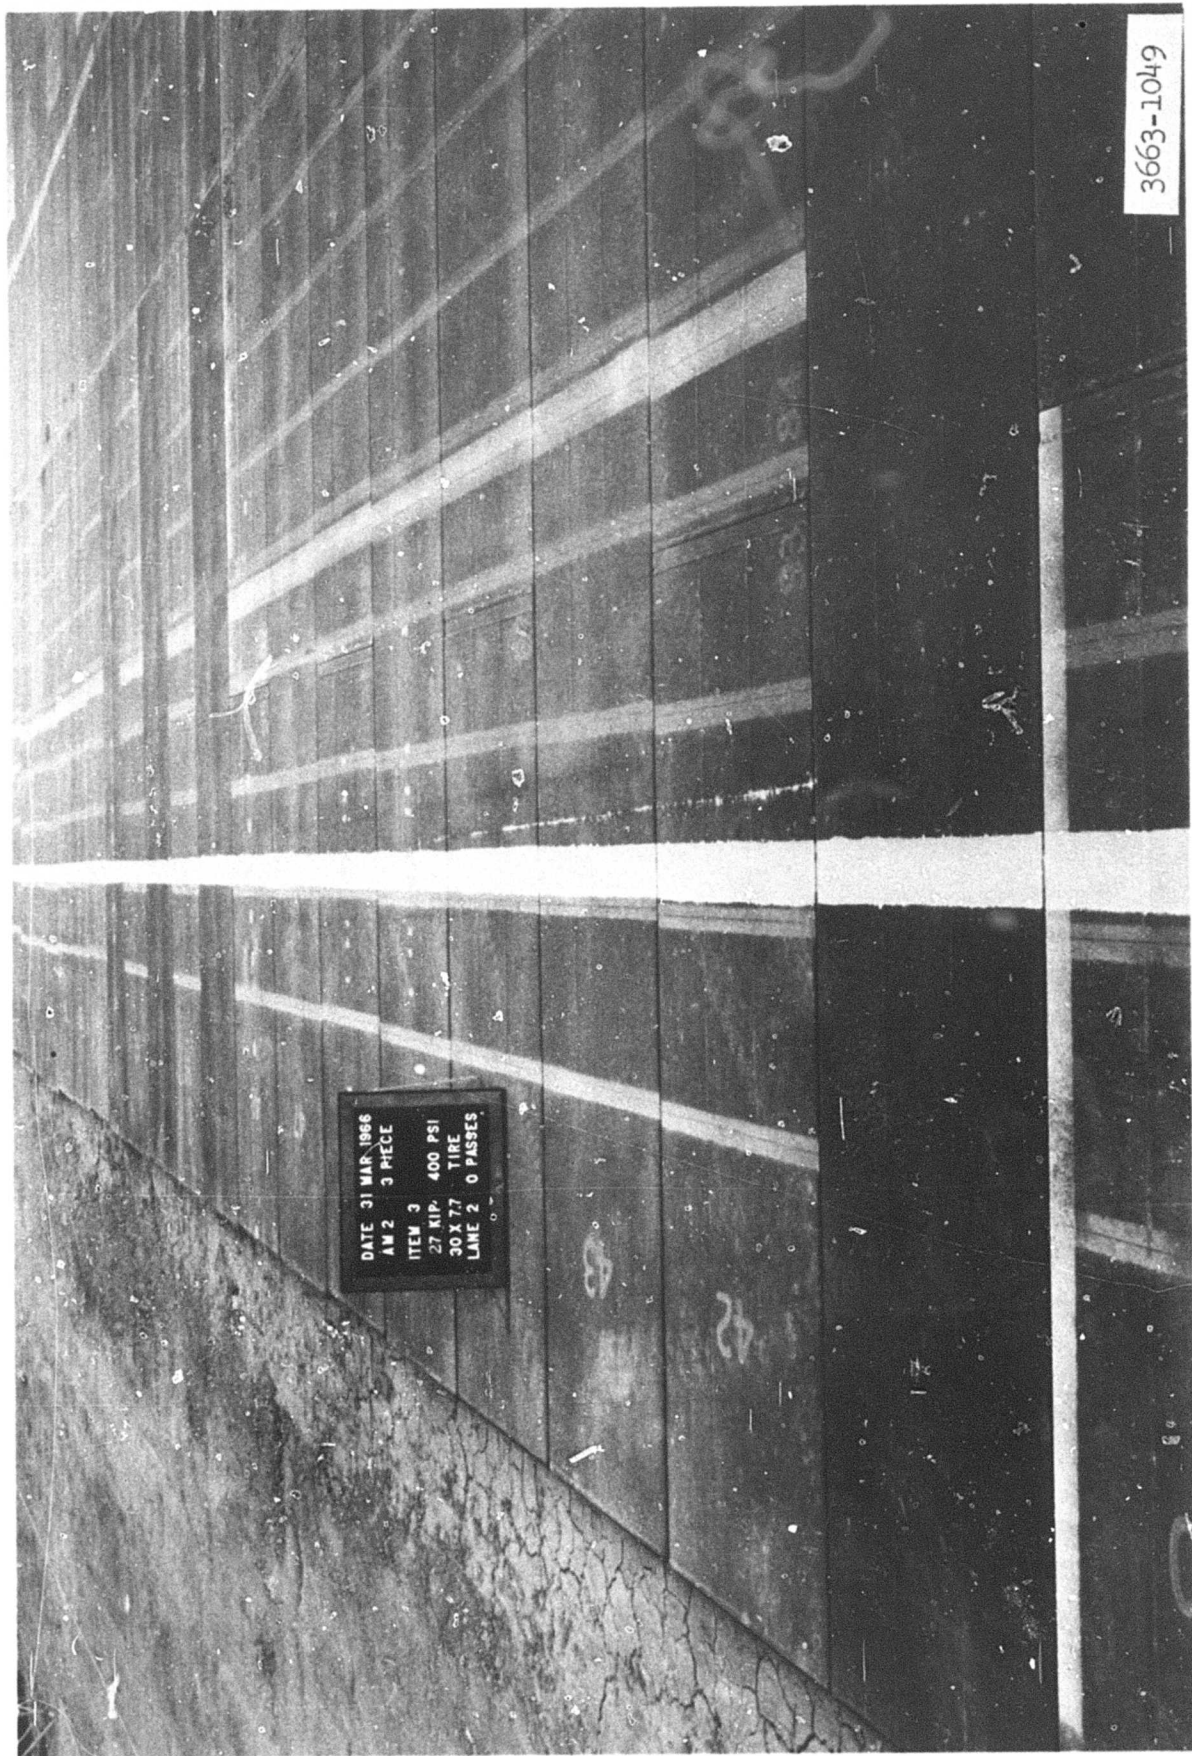
30. Item 3. Item 3 withstood 1600 passes of traffic with no apparent mat damage. Views of item 3 before and after the traffic test are shown in photographs 25 and 26, respectively.

Photograph 25. Item 3, lane 2, prior to traffic

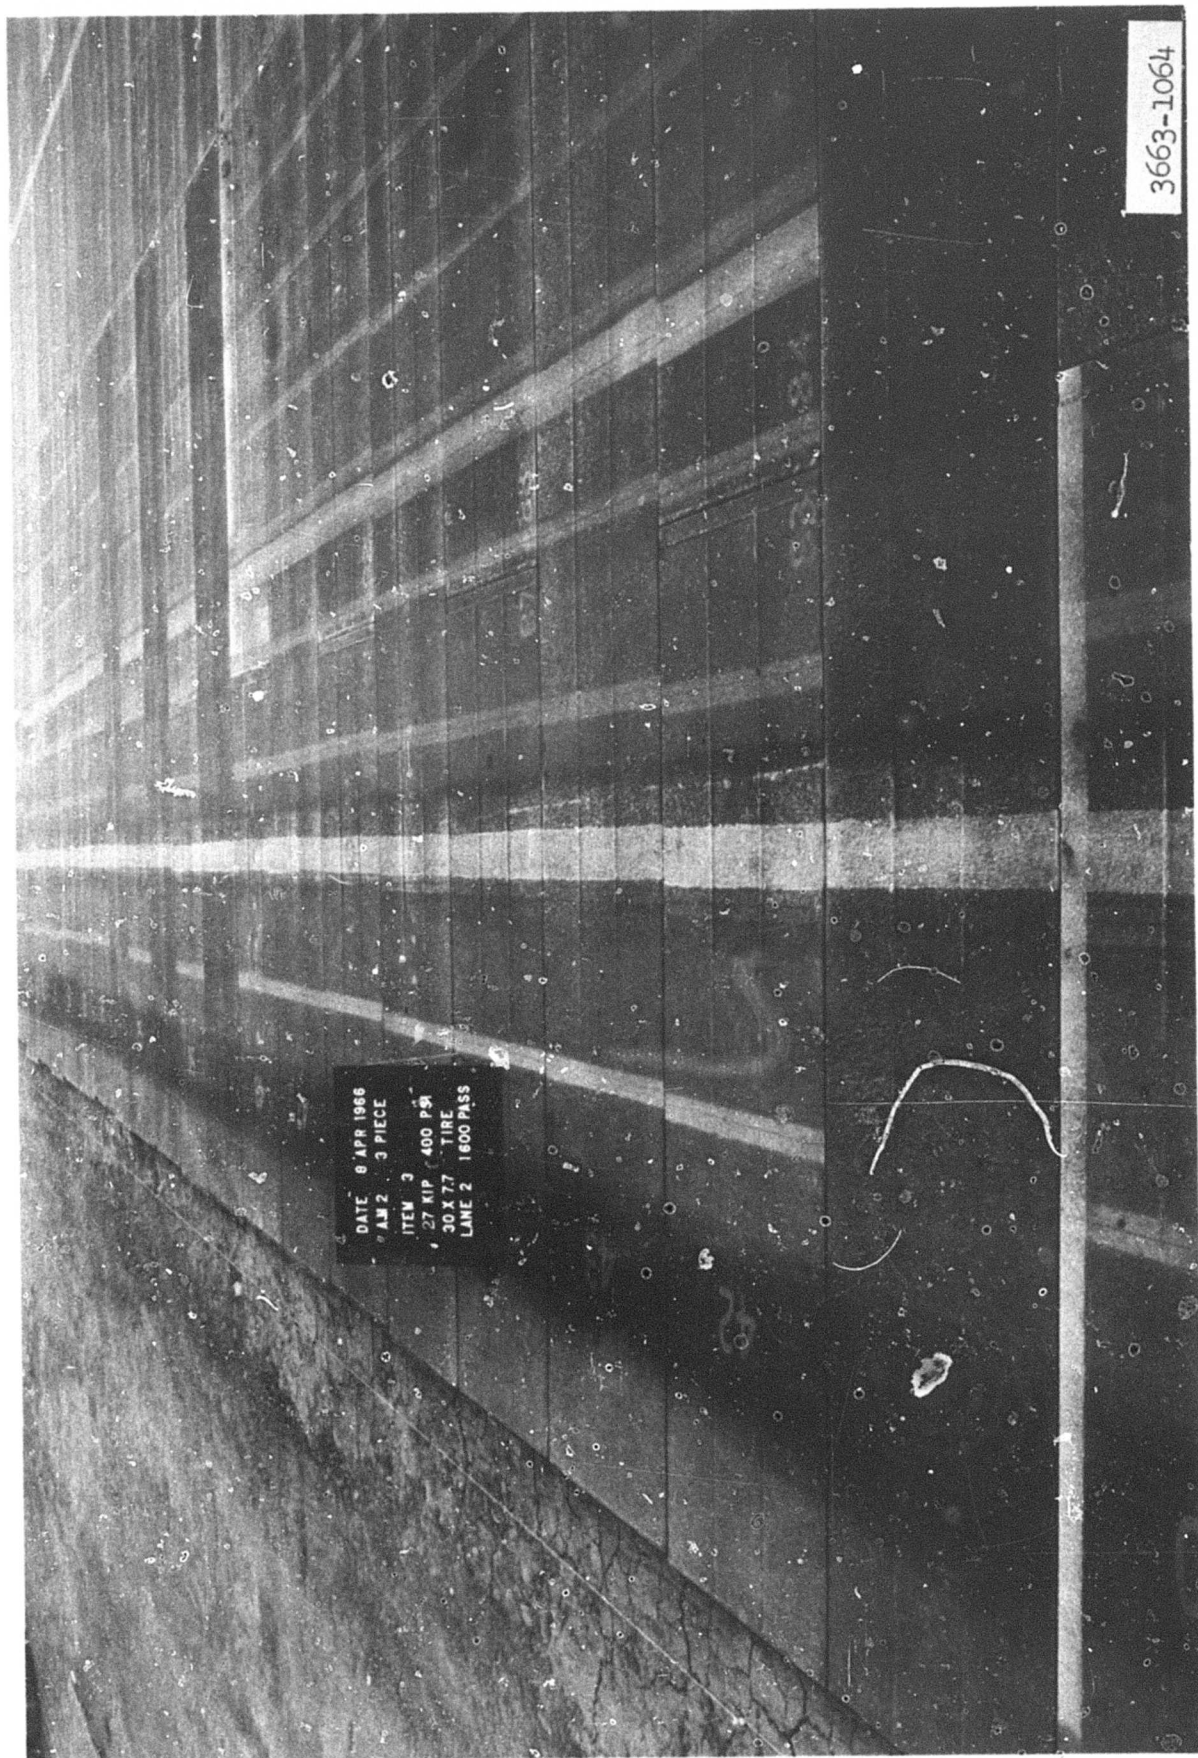
Photograph 26. Item 3, lane 2, after 1600 passes

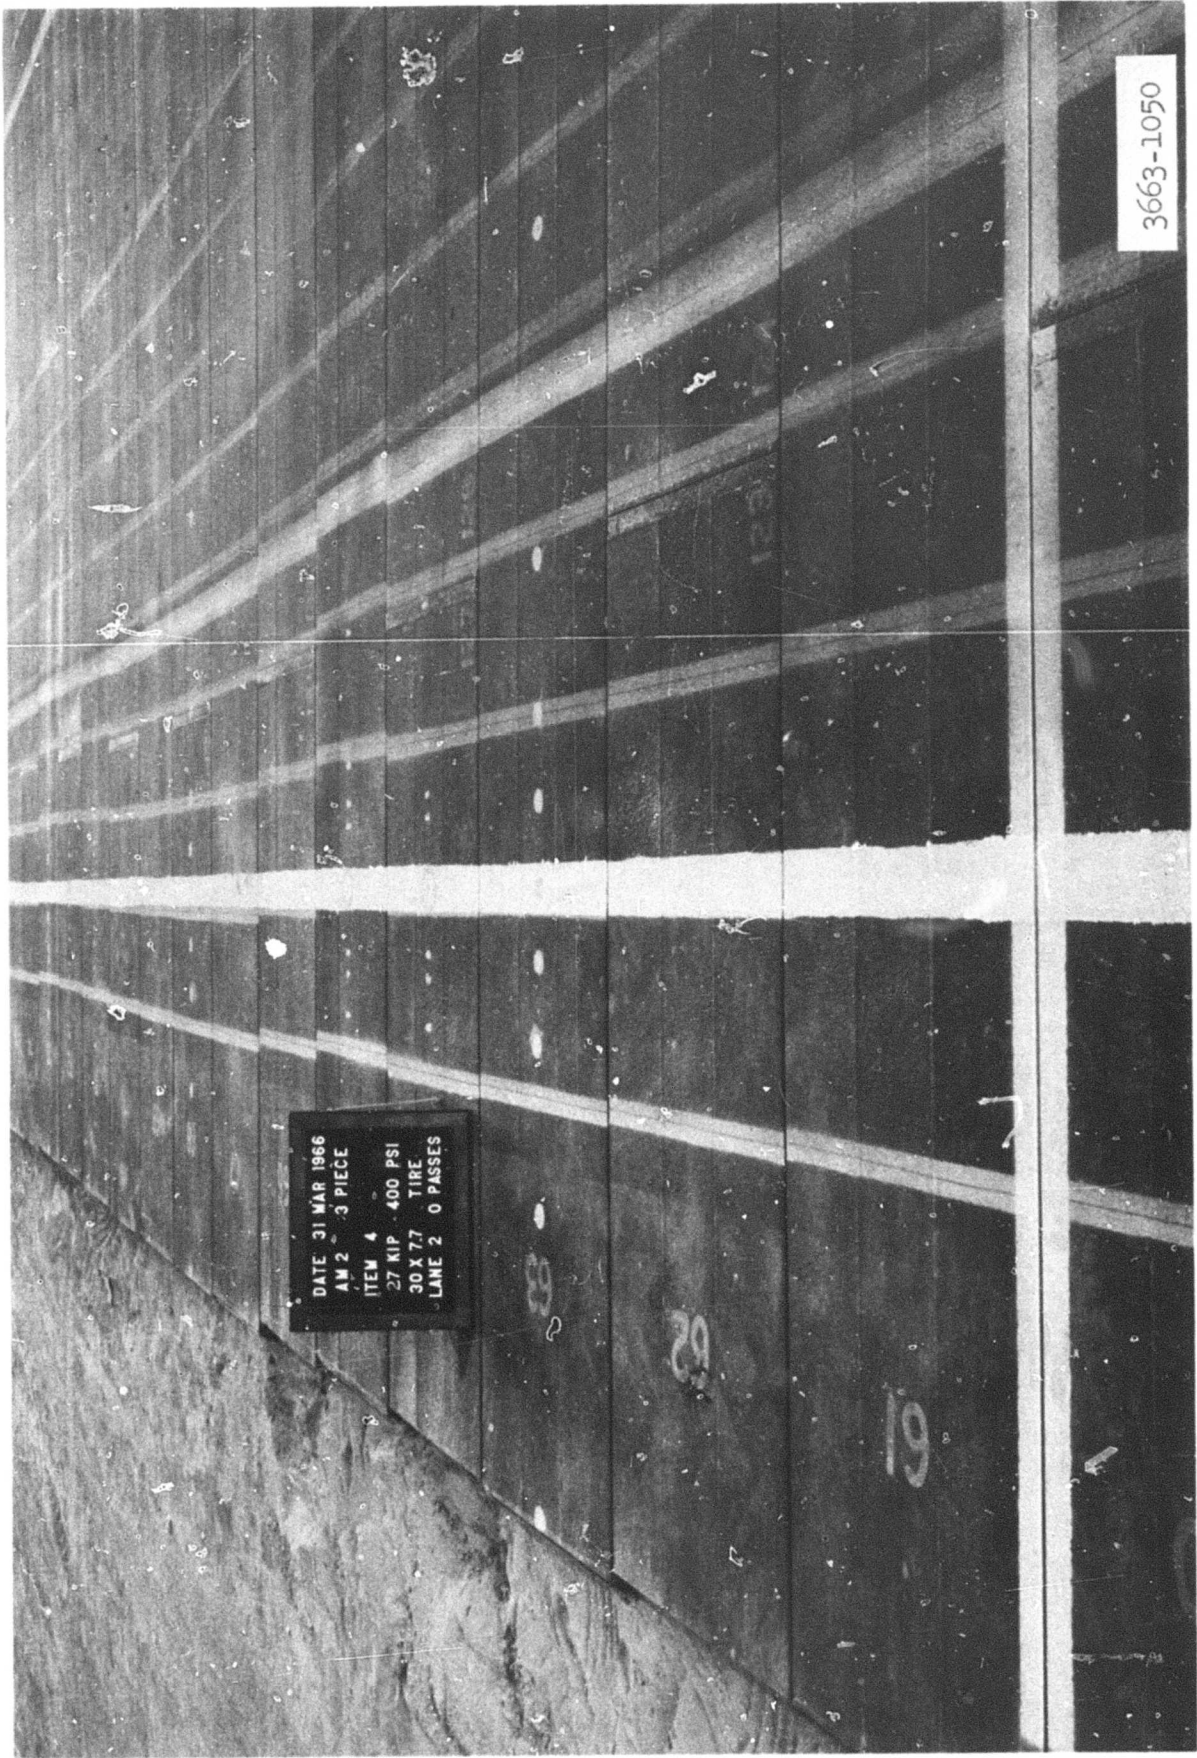
31. Item 4. Item 4 withstood 1600 passes of traffic with only one area of apparent core damage and no exterior mat breakage. When traffic was stopped, plank 147 had a $1/4$ -in.-deep dish in the extrusion on the north side of the plank. Views of item 4 before and after traffic are shown in photographs 27 and 28, respectively.

Photograph 27. Item 4, lane 2, prior to traffic

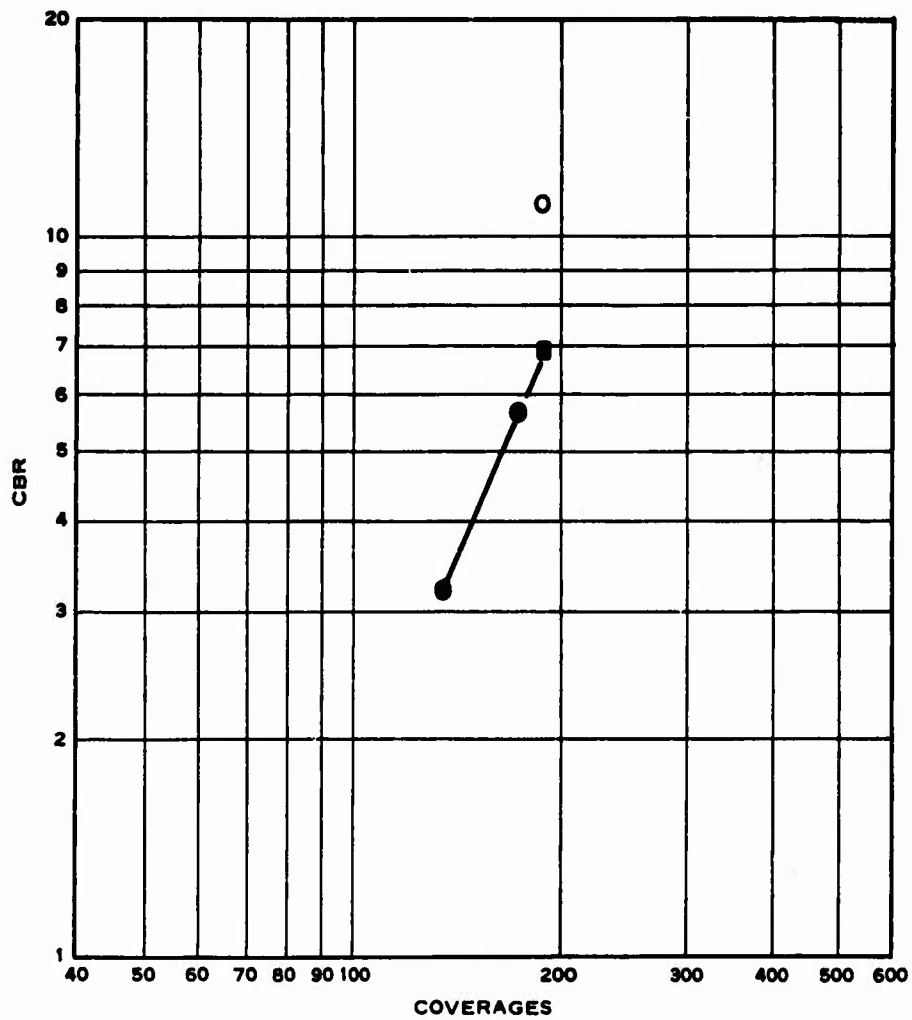
CBR VERSUS COVERAGES
UNIFORM-COVERAGE TRAFFIC
CLAY SUBGRADE

39. A plot of CBR versus coverages for the uniform-coverage traffic is shown in plate 9. The points plotted are the rated CBR values listed in table 2 for the clay subgrades and the corresponding number of coverages at the end of traffic. From previous tests on landing mats, it has been established that the CBR-coverage relation for landing mat is essentially a straight line when plotted to a log-log scale. Therefore, the linear projection through the two failure points on plate 9 indicates the CBR required to support a 27,000-lb single-wheel load with 400-psi tire pressure for various coverage levels. The indicated CBR required to support 188 coverages of traffic is approximately 6.8.
